An Insight on Non-Destructive Testing of Refractory Materials for Continuous Monitoring to prevent Unusual Breakdown

Department of Metallurgical Engineering, Kazi Nazrul University, Asansol-713340, India

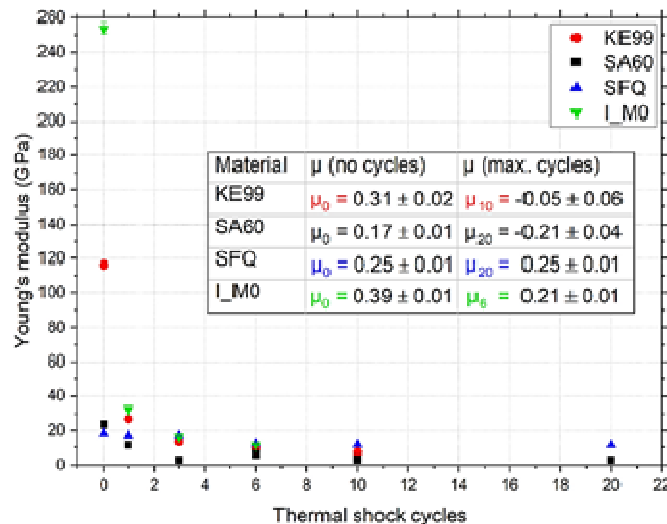
Fig. 6. Thermal shock cycle dependence of Young's modulus and Poisson's ratio for KE99 (red), SA60 (black), SFQ (blue) and I_M0 (green). [5]

To evaluate thermal shock damage, samples were heated to **950 °C** and rapidly quenched to **10 °C**, repeating up to **20 cycles**. This caused significant degradation in mechanical properties. For **KE99**, Young's modulus dropped sharply from **116 GPa to 7 GPa after 10 cycles**, (Fig. 6) with the largest decrease occurring after the first cycle. Its **Poisson's ratio also reduced** from 0.31 to -0.05, indicating severe internal damage.[5]

Similarly, **SA60** showed a decline from **24 GPa to 3 GPa (20 cycles)** and Poisson's ratio from 0.17 to -0.21. **I_M0** exhibited rapid deterioration, decreasing from **254 GPa to 11 GPa within just 6 cycles**, with Poisson's ratio dropping from 0.39 to 0.21. These rapid reductions suggest **low thermal shock resistance**.

In contrast, **SFQ** showed a gradual and smaller decrease in Young's modulus (**18 GPa to 11 GPa**) while Poisson's ratio remained constant (0.25), indicating **better resistance to thermal shock**.[5]

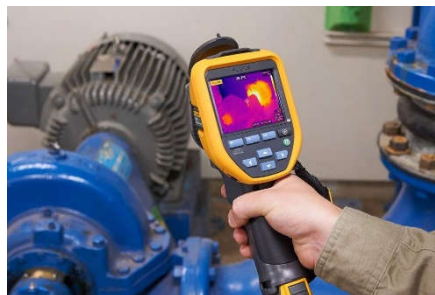
Fig. 8. Infrared Camera

Thermography allows real-time, non-contact monitoring of linings while the plant is still operating. A five-year monitoring program on a **Fluid Catalytic Cracking Unit (FCCU)** in a UK refinery showed significant benefits. It helped engineers identify damaged areas early and plan maintenance before shutdowns. Earlier, repairs were only done after internal visual inspections during shutdowns.[6]

With thermographic monitoring, unplanned refractory repairs were almost eliminated. The method is also effective for monitoring process furnaces and flue gas ducting, improving maintenance planning, safety and overall efficiency.[1][2][3]

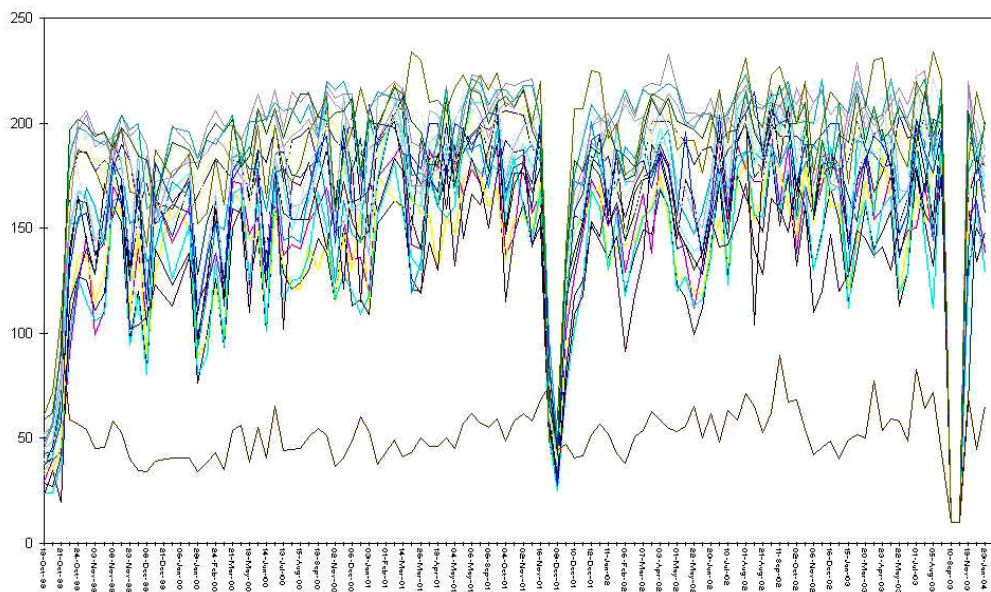
Fig. 10. Trend of Regenerator Shell Surface Temperature Results Over Time [6]

Fig. 9 and Fig. 10 are the examples from the monitoring spreadsheet and show the surface temperature trend over the last five years for two different areas of the plant. In these five years, temperature trends generally increased, which is normal as catalyst erosion reduces refractory thickness, increasing heat transfer to the outer shell. Using known thermal conductivity data, engineers estimated remaining refractory thickness and predicted maintenance needs accurately.

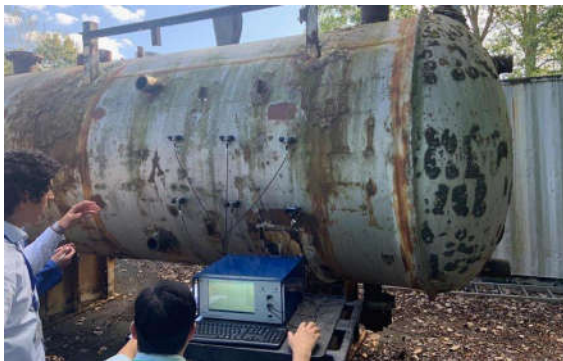
Fig. 16. AE Sensors are Attached at The Surface

Sensitive AE sensors, typically piezoelectric transducers, are attached to the surface of the structure to detect these waves. The detected signals are then amplified, processed and analysed to determine the source and severity of the damage. Unlike conventional NDT methods, AE does not require external energy input; instead, it listens to the energy released by the material itself.[1][2][3]

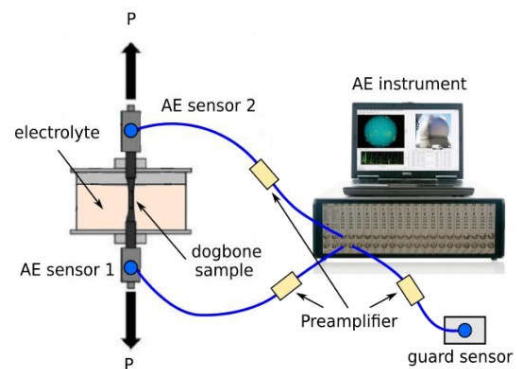
Fig. 17. Amplification and Analysis of Detected Signals

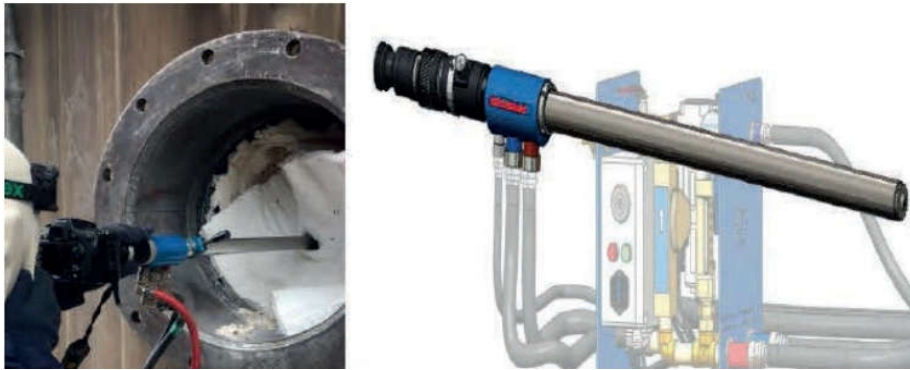
Fig. 23. Endoscopic Camera

reactors without dismantling the equipment. It enables the detection of defects such as cracks, delamination, erosion and slag build-up by providing a clear, real-time view of internal surfaces even for confined or complex geometries where direct human access is difficult or unsafe.

Flexible or rigid borescopes can be inserted through small openings, allowing detailed inspection of hard-to-reach areas. It is particularly valuable during maintenance checks, shutdown inspections and troubleshooting. By identifying damage early, this technique helps in planning targeted repairs, reducing downtime and ensuring safe and efficient operation of industrial systems.

- *Advantages:* Endoscopic or visual inspection offers several important advantages in industrial applications, particularly in monitoring refractory linings. One of the primary benefits is reduced downtime, as inspections can often be carried out without complete dismantling or prolonged shutdown of equipment. This leads to significant cost savings in both maintenance and production losses. The method also allows real-time assessment of internal conditions, enabling quick identification of defects such as cracks, erosion, or slag accumulation.
